NBSIR 85-3158

Fire Performance of Interstitial Space Construction System

**U.S. DEPARTMENT OF COMMERCE
National Bureau of Standards
National Engineering Laboratory
Center for Fire Research
Gaithersburg, MD 20899**

May 1985

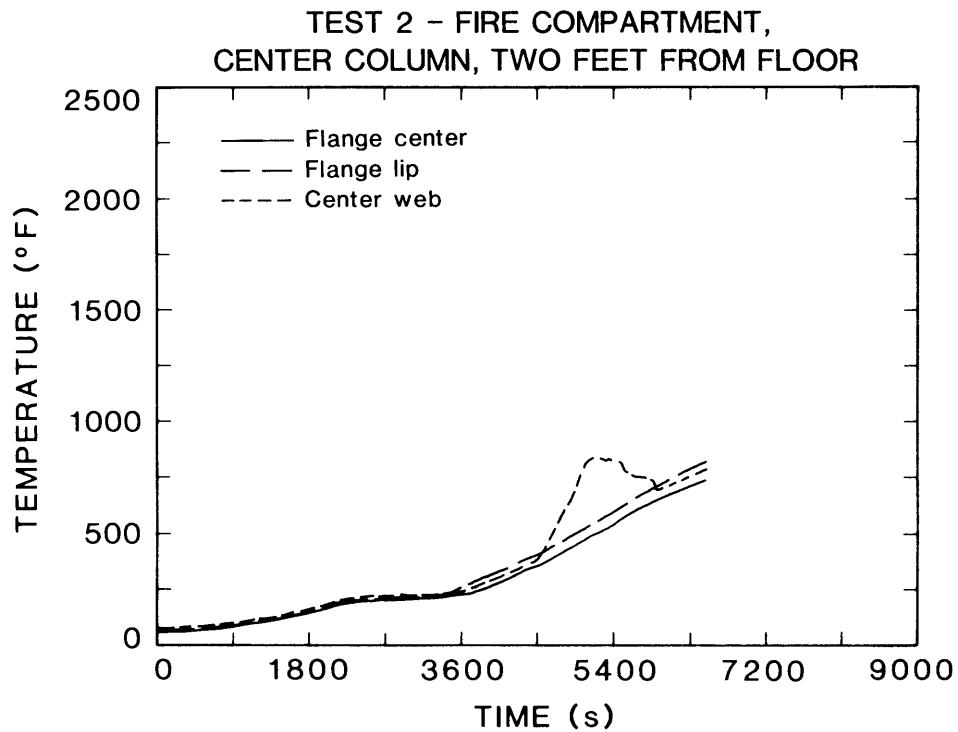
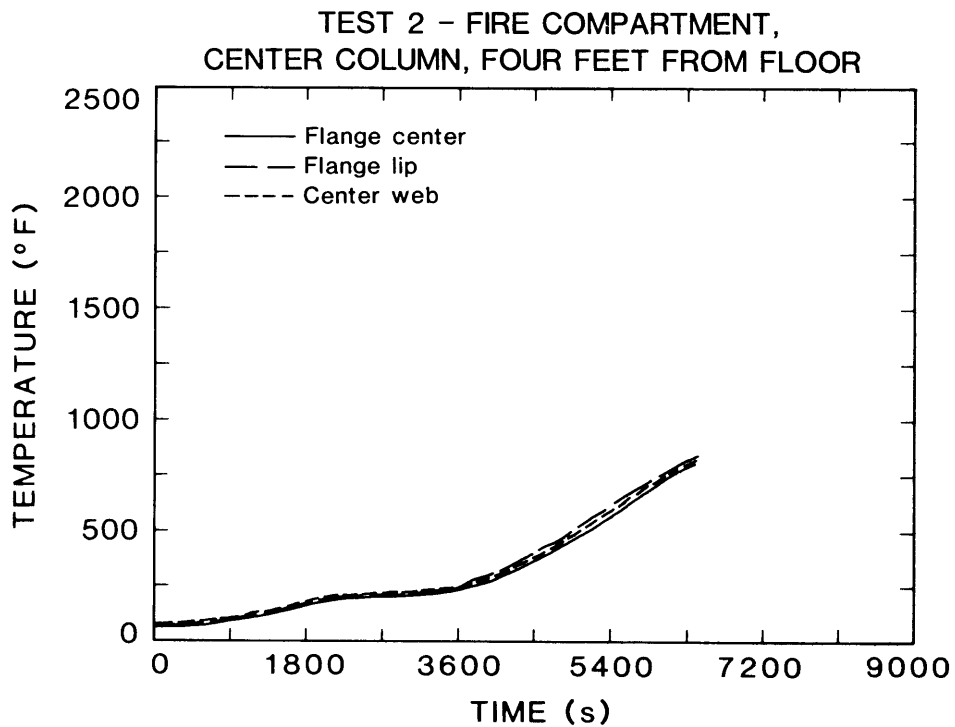
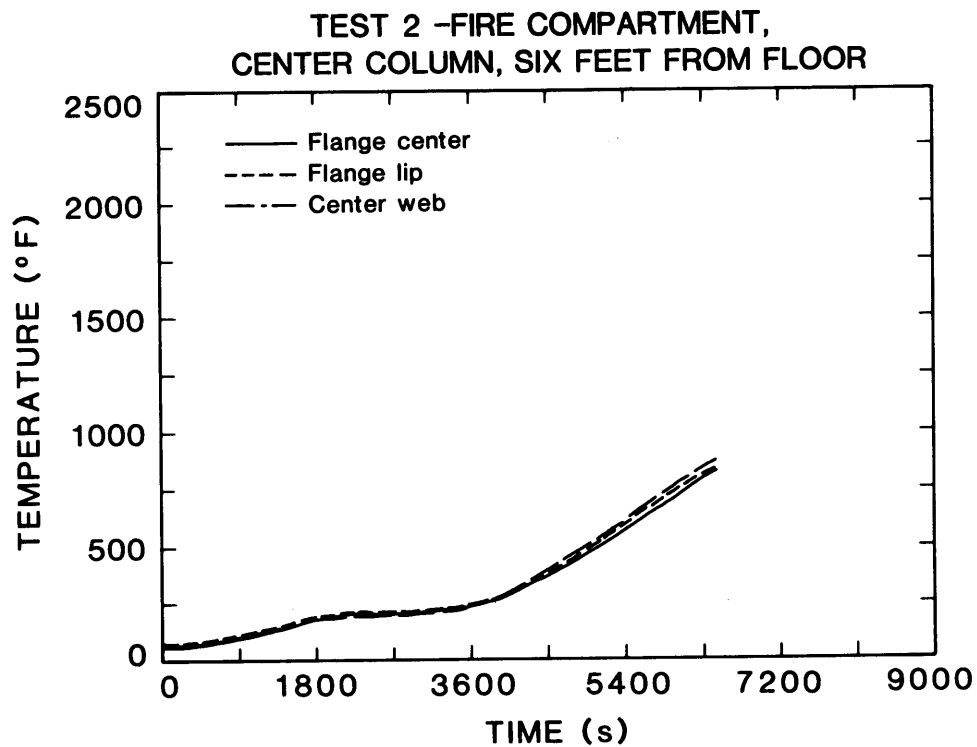
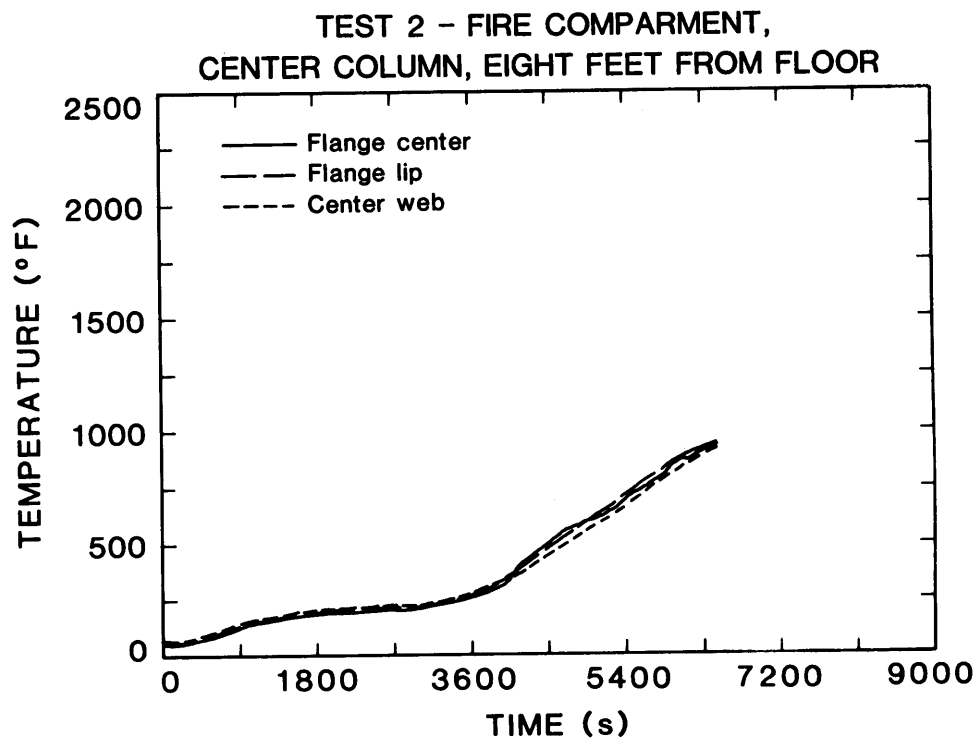
section that was exposed to the fire compartment. The maximum test temperature for the column was 937°F, and it occurred 18 minutes after the furnace burner was turned off. The fireproofed purlins supporting the walk-on deck performed well, figures 68 to 71. As stated in section 5.2.2, all fireproofing stayed on the purlins. This resulted in a maximum purlin temperature for this short test of only 354°F, figure 71. The walk-on deck temperatures are shown in figures 72 to 75. These temperature plots show similarity with the data obtained in test 1. The maximum surface temperature measured was 205°F. This again occurred after the burner was turned off, but the overall floor performance is much like that seen in test 1. Temperature plots for the walk-on deck suspension rods and steel tube bracket are shown in figure 76. Heat transfer through the purlins and the suspension system was clearly reduced as a result of the fireproofing remaining in place. The temperature of these structural elements remained significantly low throughout the test exposure. Figures 77 and 78 provide information on duct temperatures and air temperatures in the interstitial space. Again, these temperature plots show similar performance to that experienced with the first test. However, a major difference is seen in figure 79 when compared with figure 49 of test 1. Test 2 shows very little movement in purlin deflection measurements. Since the purlins and walk-on deck system of test 2 appeared to maintain much of their initial strength after this aborted test, it was decided to conduct another full two hour test on the same assembly in an attempt to obtain additional information. Only the fire protection on the column and pier was replaced.

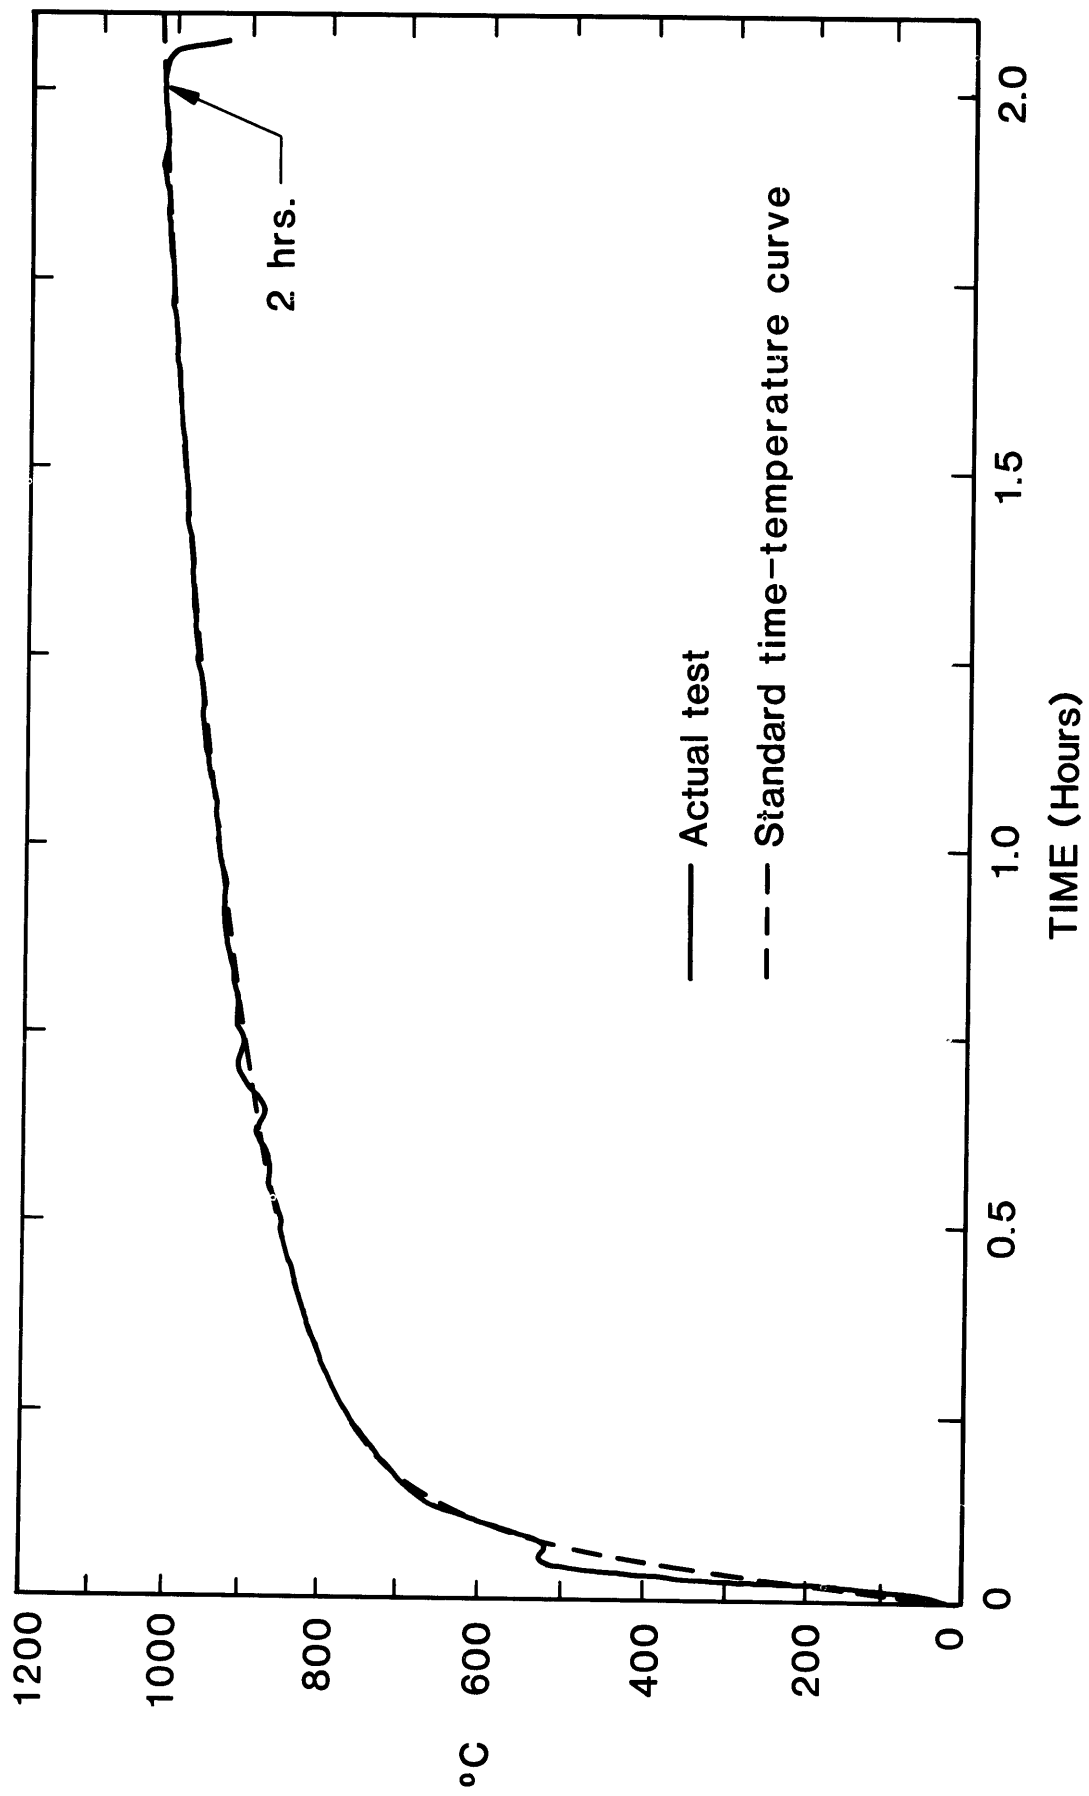
Figure 80. Chart record of average furnace temperature, test 2A

The record showing the average furnace temperature throughout the two hour test is presented in figure 80. It should be noted that the assembly exposed to this standard fire test was the same assembly tested for 1.5 hours the day before. This should be kept in mind when comparing test results. The gypsum board protection on the column and pier was replaced for test 2A.

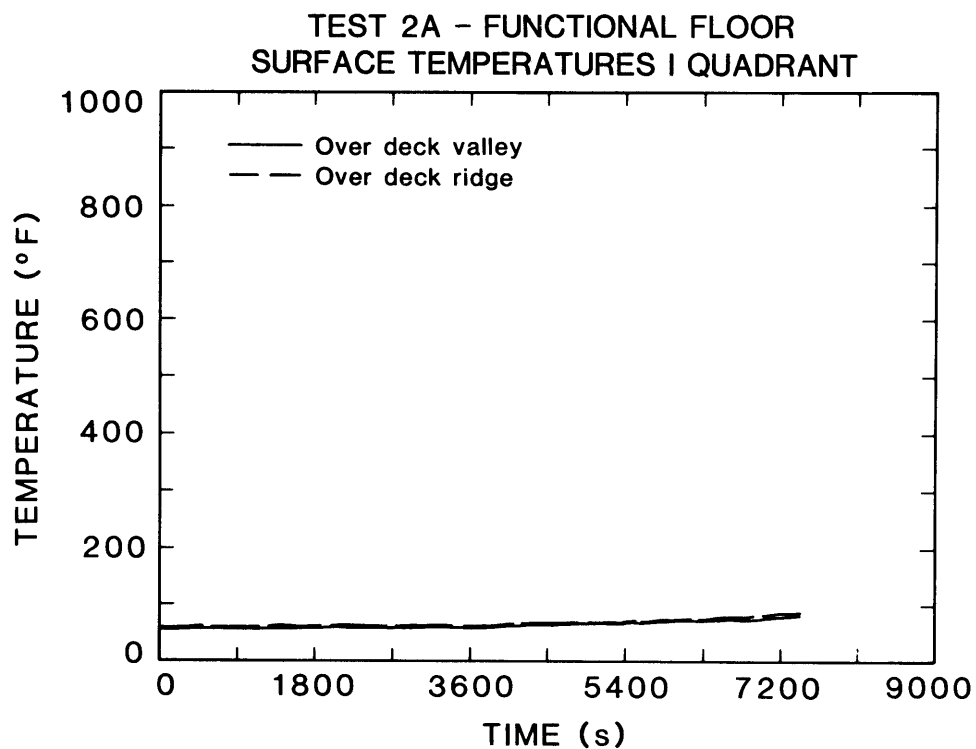
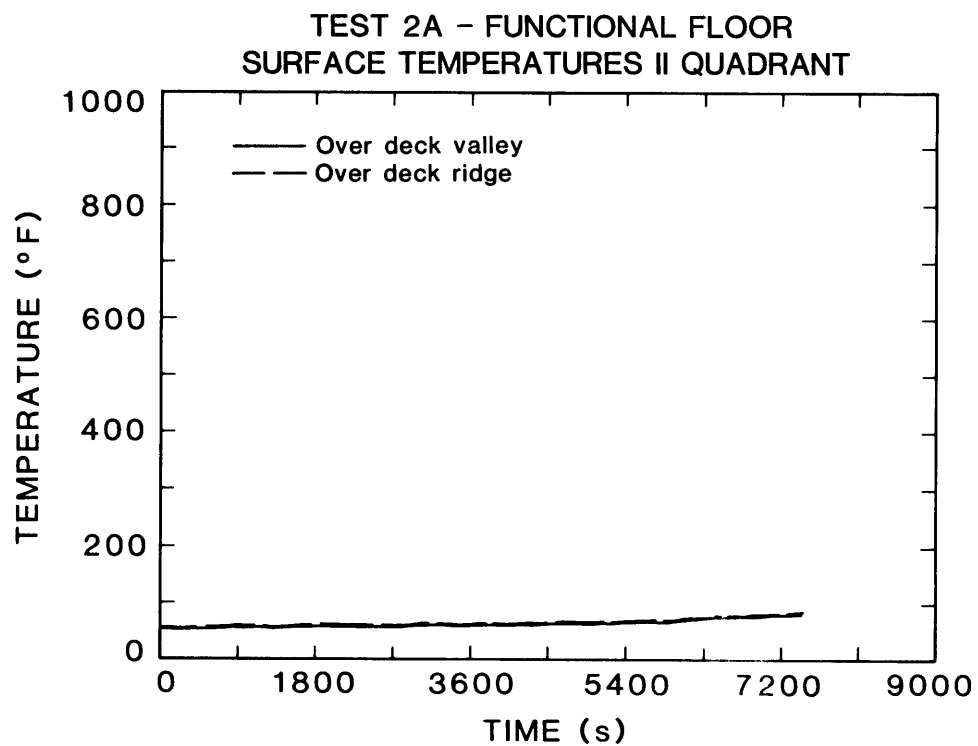
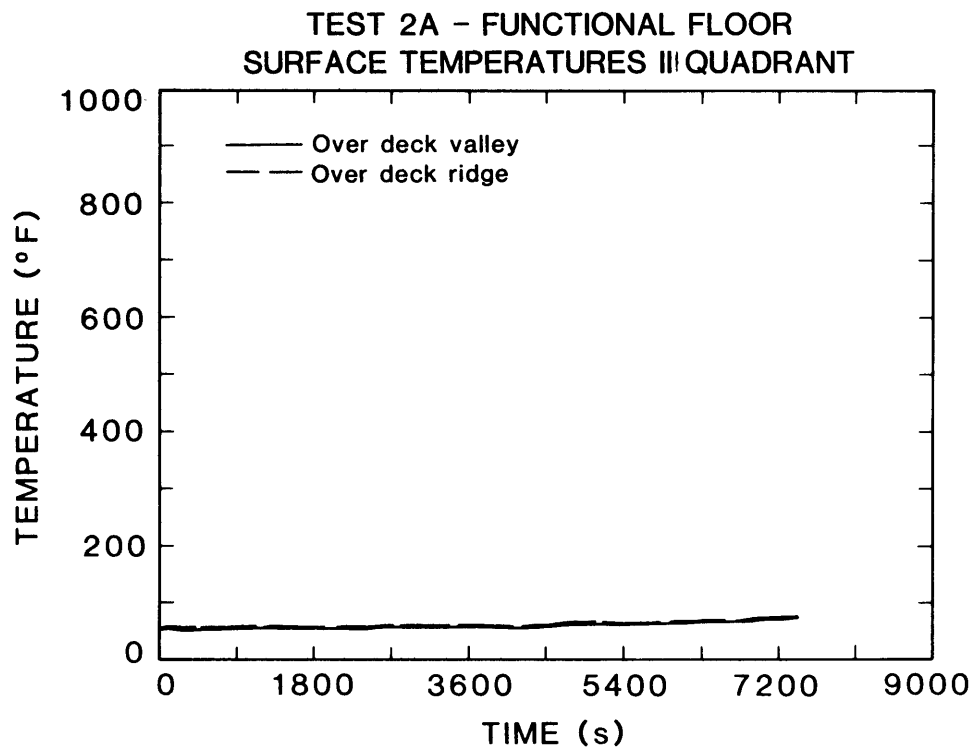
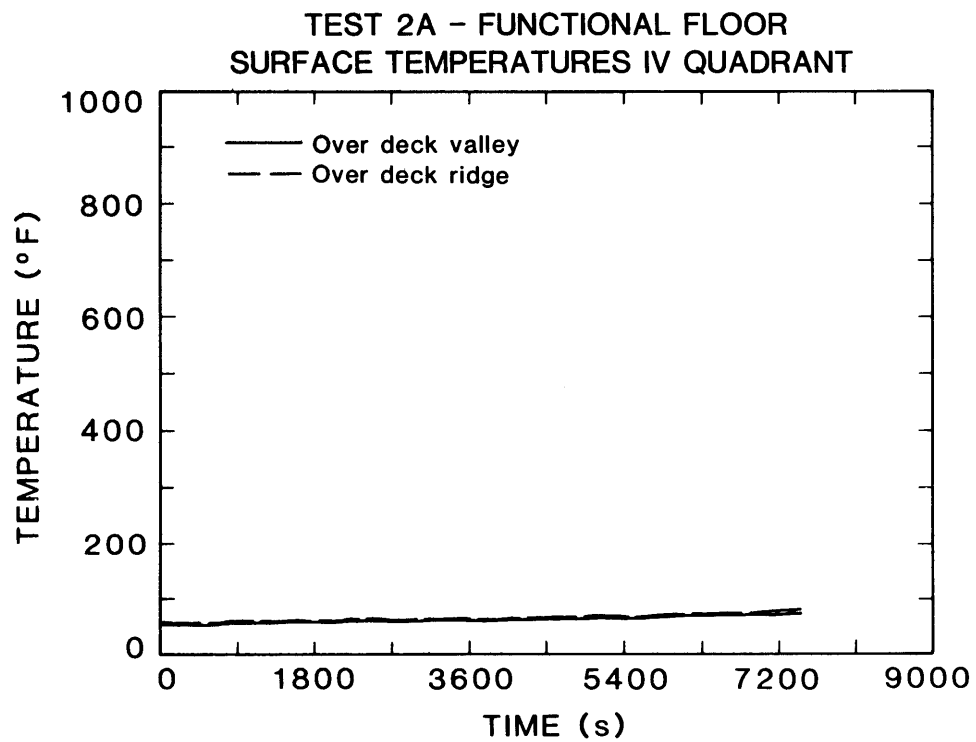
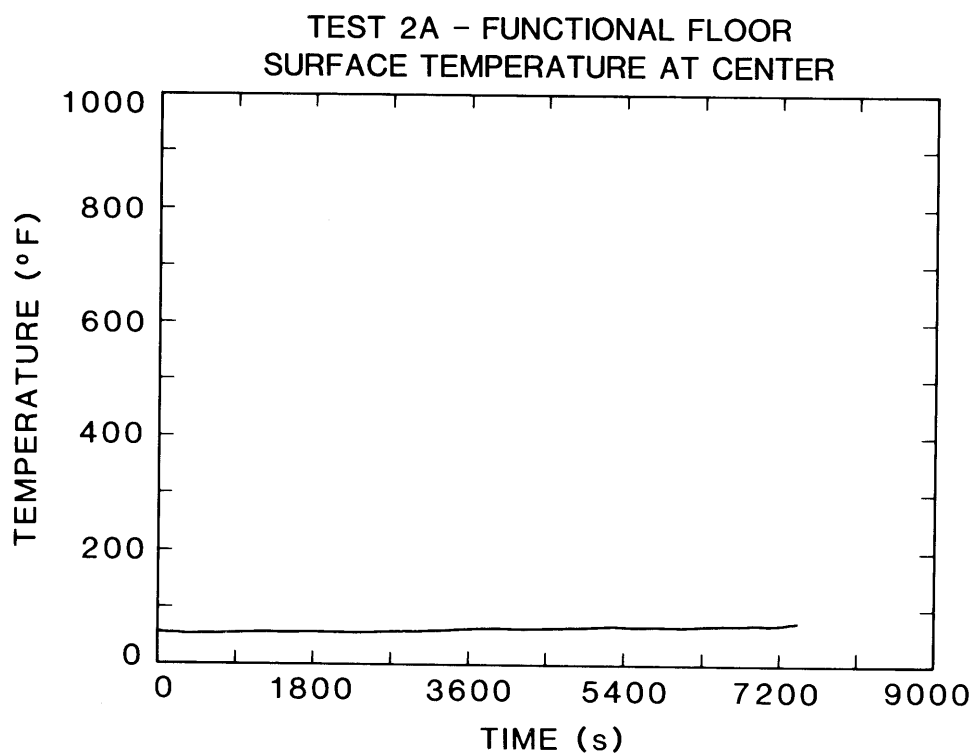
Heat transmission through the functional floor during the second exposure of the test assembly was limited, figures 82 to 86. The maximum temperature on the unexposed surface of the functional floor was 88°F. The steel deck supporting the floor experienced a maximum temperature of 156°F which was 18°F more than that during test 2, figure 87. In addition, the center beam supporting the walk-on deck also showed higher temperatures than recorded in tests 1 or 2, figures 88 and 89. The maximum temperature in this test for the beams was 201°F. The center column in the interstitial space also performed well during this second exposure, figures 90 and 91. It should be remembered that the gypsum board system protecting the center column in the fire compartment was completely rebuilt for test 2A. As seen in figures 92 to 95, the column did not remain adequately protected in the fire compartment. A

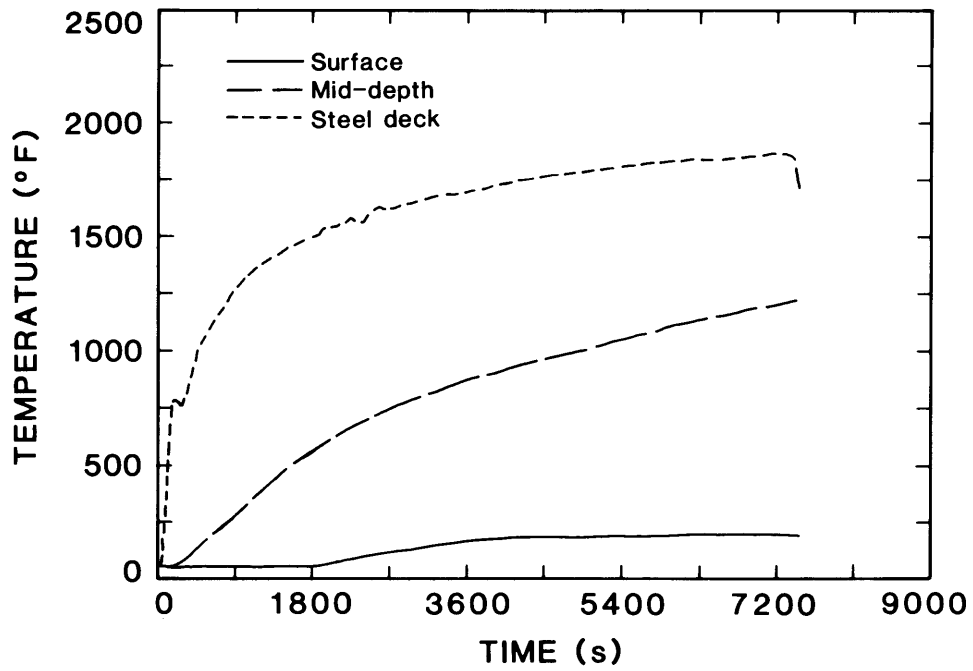
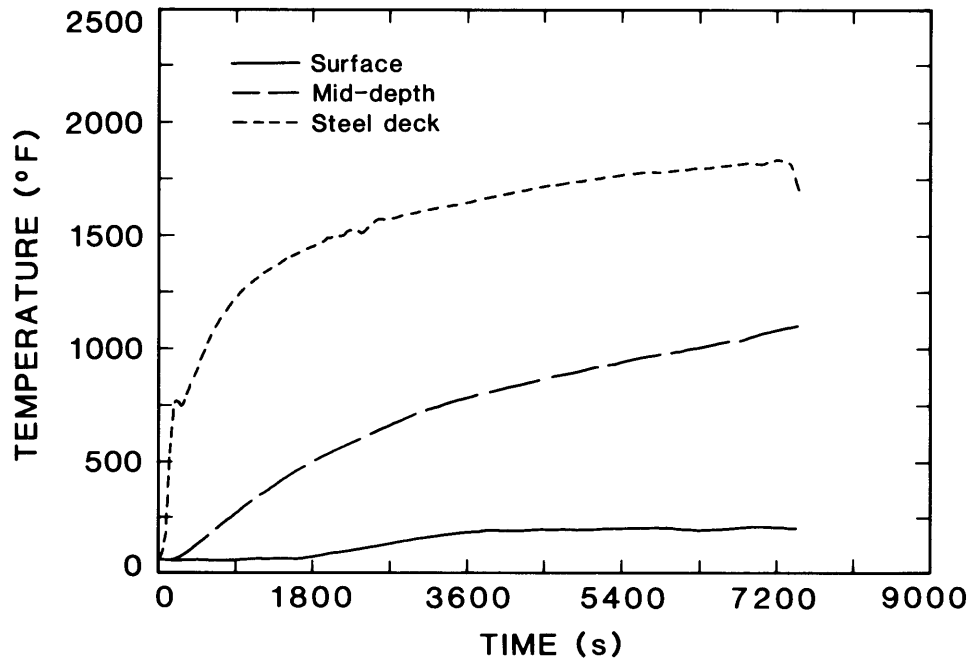
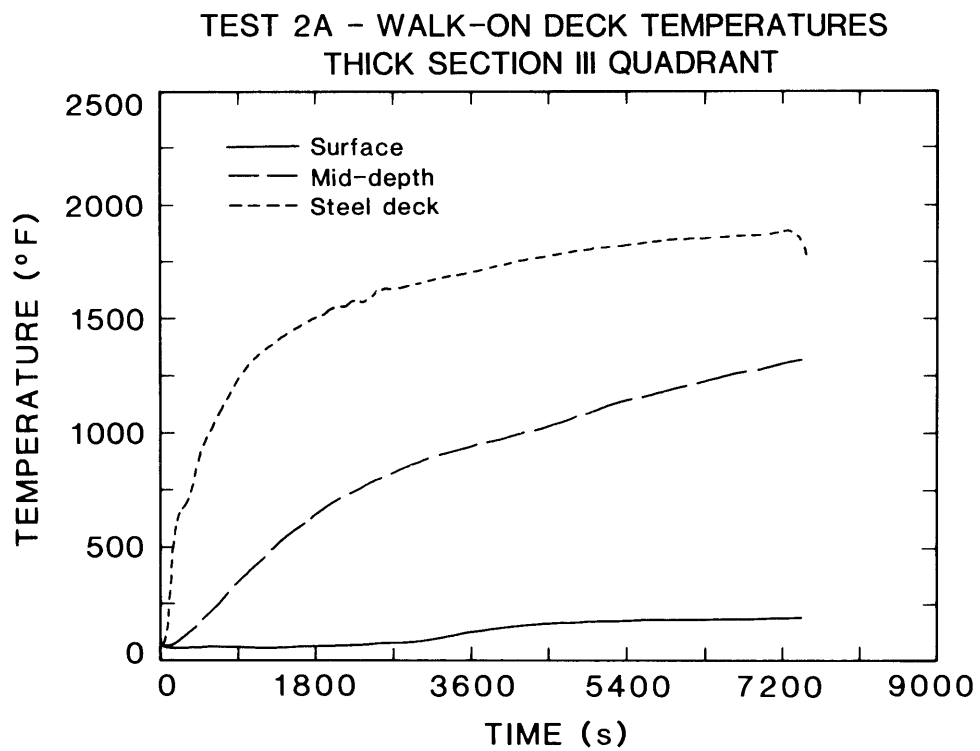
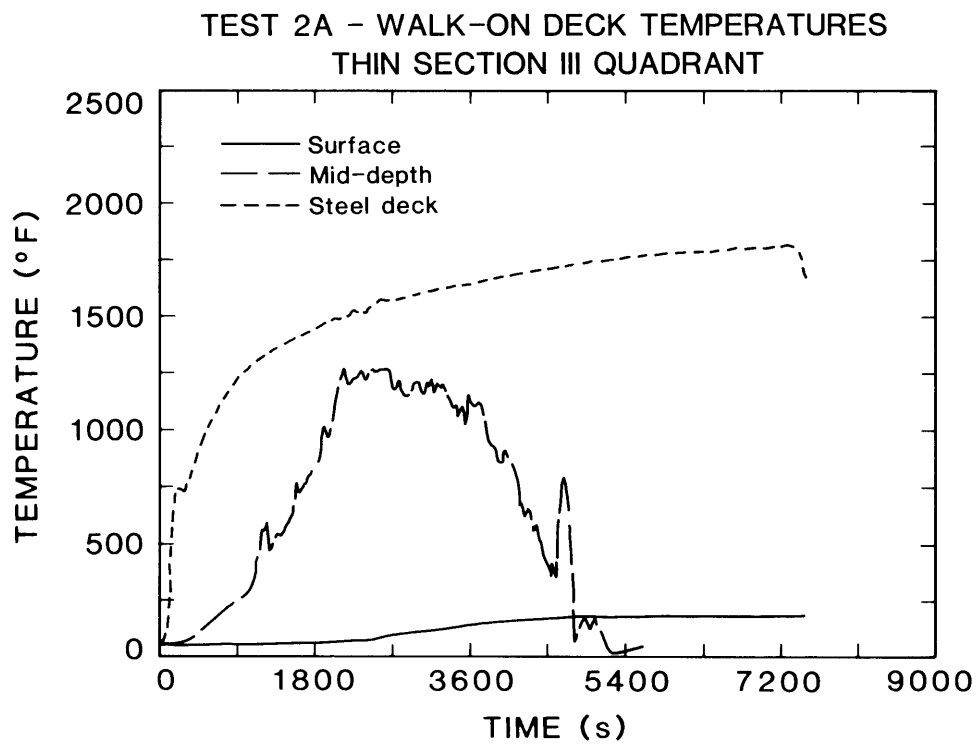
The walk-on deck during this test generally performed better than the walk-on deck in test 1, figures 100 to 103. This deck did not show the amount of cracking noted at the end of test 1. The suspension rod and steel tube bracket temperatures are presented in figure 104. Temperatures recorded for the dummy air conditioning ducts, figure 105, are similar to results obtained during tests 1 and 2. Air temperature in the interstitial space reached a maximum of 331°F. This is only 36 degrees higher than that experienced in test 1. Particular attention was paid to the purlin deflections recorded during this test, figure 107. In test 1, the deflections were random, and in test 2 the purlins moved very little. During this test the purlins showed a gradual movement in the downward direction. This movement was attributed in part to the gradual degradation of the fireproofing combined with the

Figure 100. Walk-on deck temperatures thick section quadrant I, test 2A

Figure 101. Walk-on deck temperatures thin section quadrant I, test 2A

Figure 102. Walk-on deck temperatures thick section quadrant III, test 2A

Figure 103. Walk-on deck temperatures thin section quadrant III, test 2A

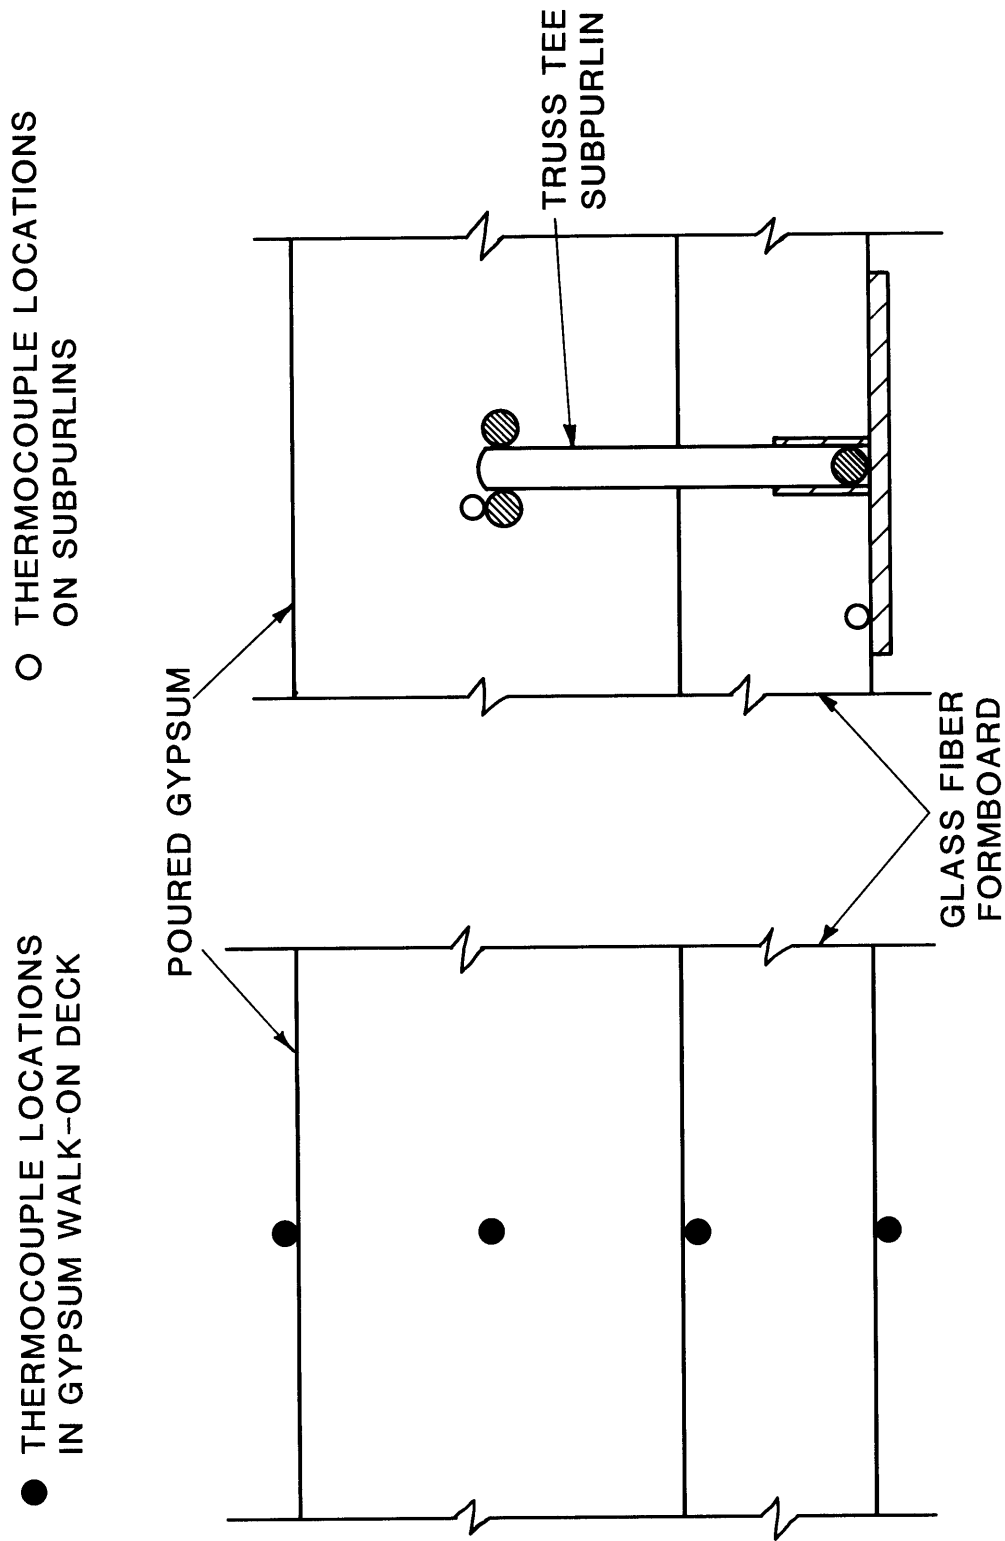
Figure 109(B). Subpurlin temperature measurement points, test 3

deck/formboard interface. A third was used to obtain the center gypsum core temperature and the fourth was used for unexposed surface temperature. This set of measurements was made at two deck locations, figure 110. A second major difference appears with temperature measurements made on the subpurlins, figure 109b. Subpurlin temperature measurement locations on the walk-on deck are shown in figure 110.

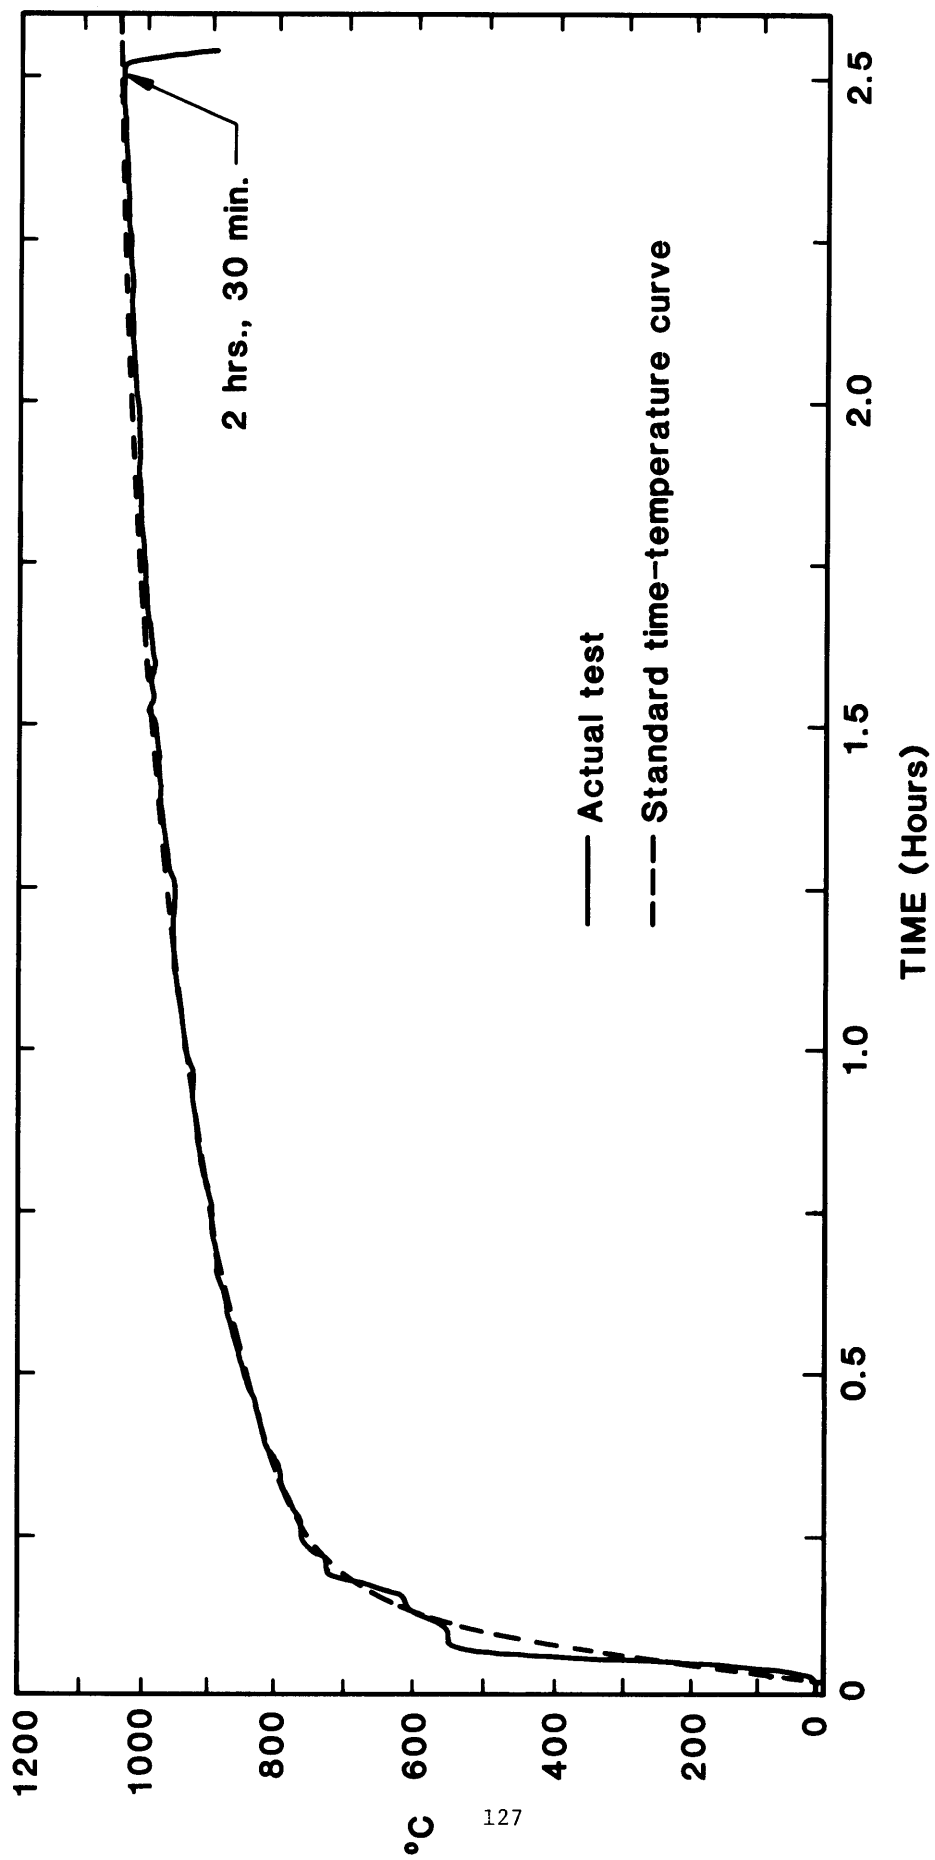
Figure 111. Chart record of average furnace temperature, test 3

A record of the average furnace temperature for test 3 as compared to the standard time-temperature curve is shown in figure 111.

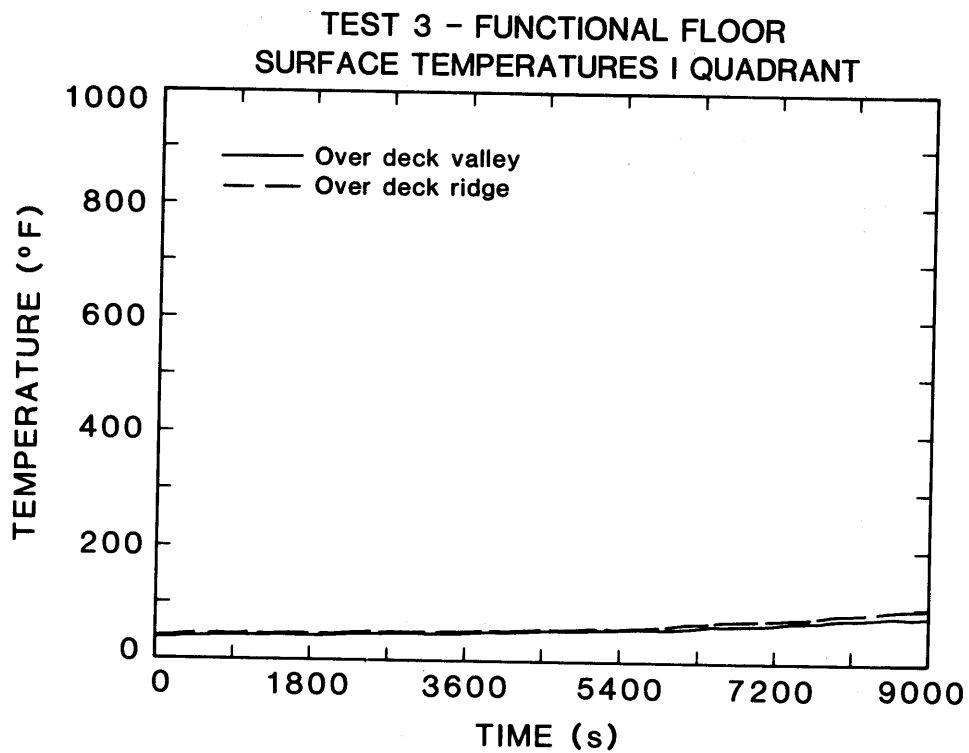
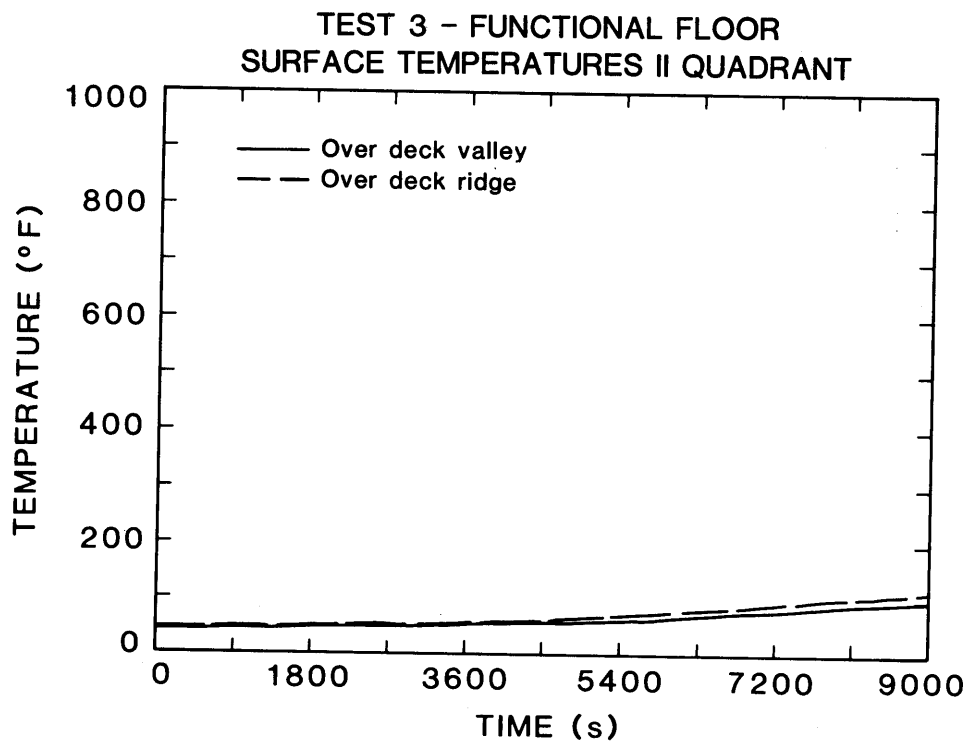
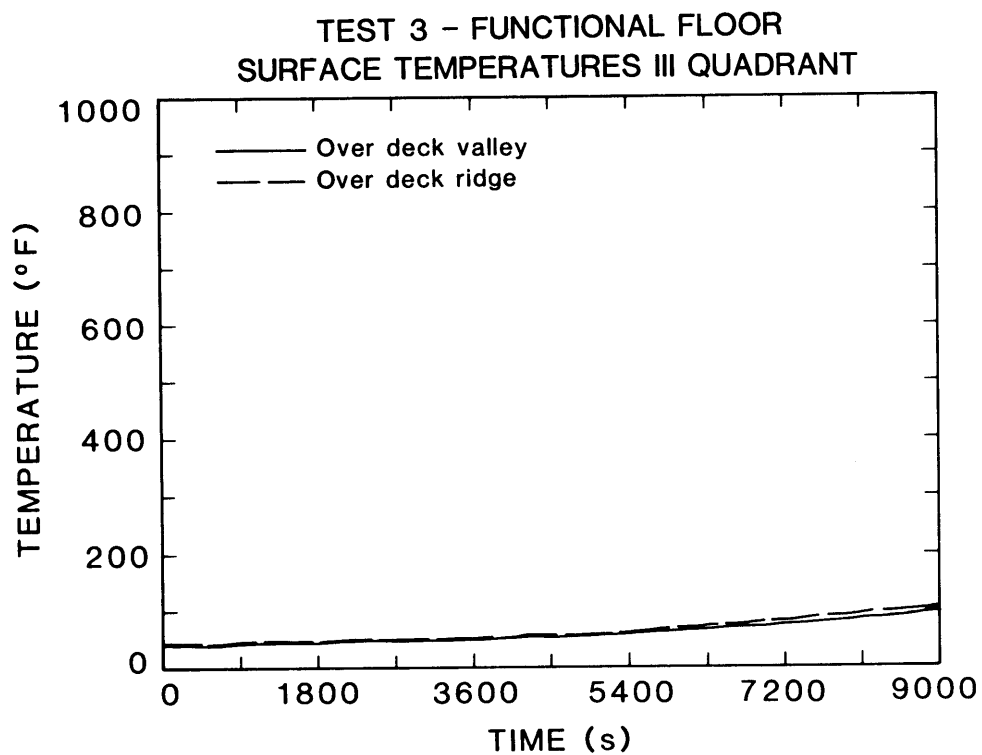
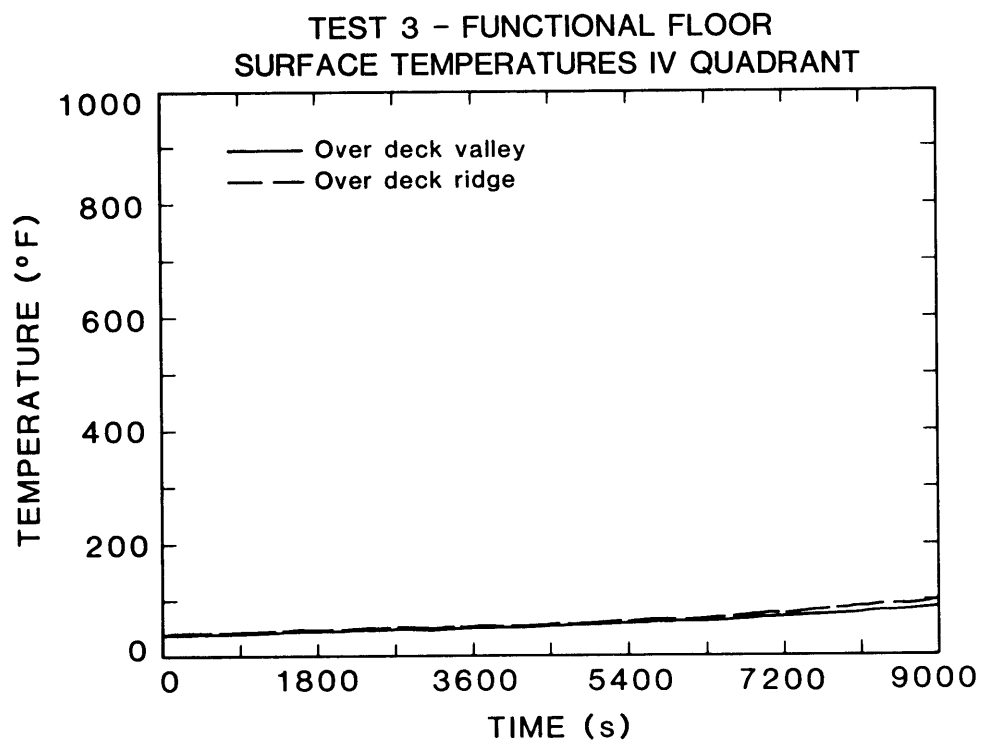
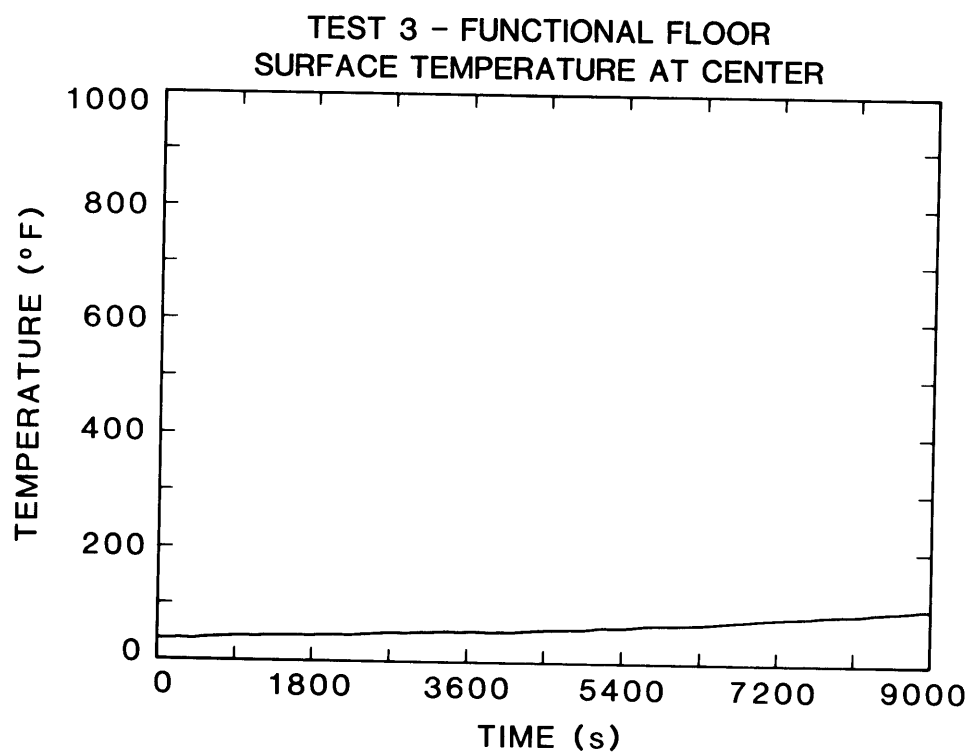
In test 3, the functional floor temperatures showed that the walk-on deck provided significant resistance to heat flow. Figures 114 through 118 show that the maximum temperature on the top functional floor surface never exceeded 115°F during the 2.5 hour exposure. The temperature of the steel deck supporting the functional floor had a maximum temperature of 176°F, figure 119. This temperature was less than that measured in test 1, but was more than 35°F higher than the maximum steel deck temperatures measured in tests 2 and 2A. These maximum deck temperatures are still well below any critical temperatures specified by the test procedure. Temperatures for the central beam supporting the functional floor are shown in figures 120 and 121. The highest temperature measured was 304°F which is substantially below the critical temperature for that structural element. This temperature was measured after 2.5 hours of test exposure. The unprotected column in the

Figure 114. Functional floor surface temperatures quadrant I, test 3

Figure 115. Functional floor surface temperatures quadrant II, test 3

Figure 116. Functional floor surface temperatures quadrant III, test 3

Figure 117. Functional floor surface temperatures quadrant IV, test 3

Figure 118. Functional floor surface temperature center of test bay, test 3

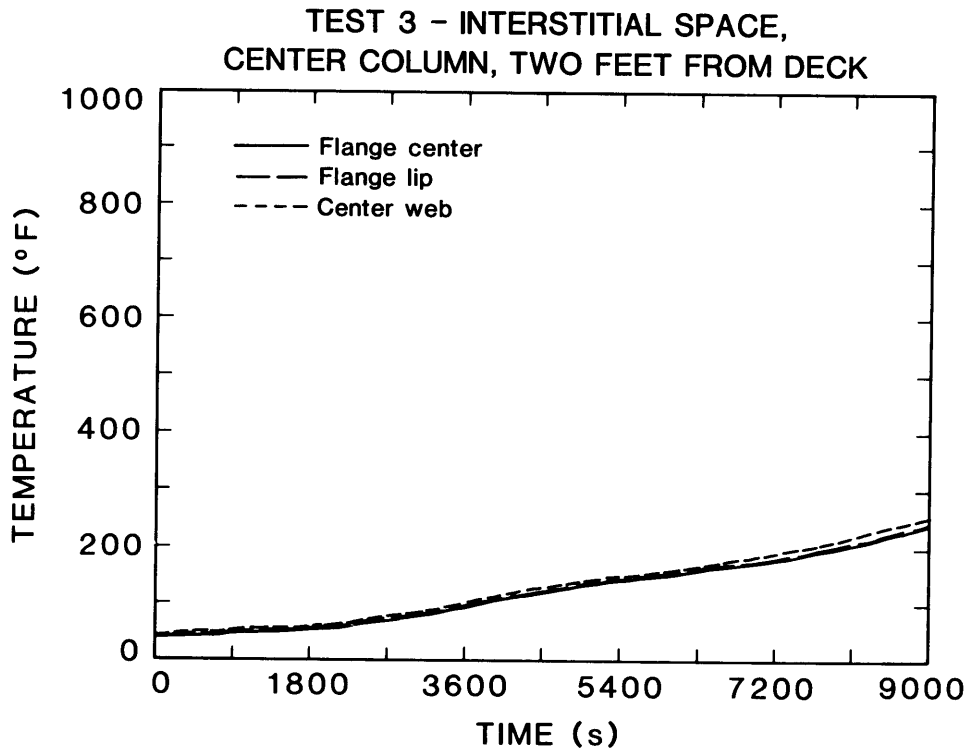
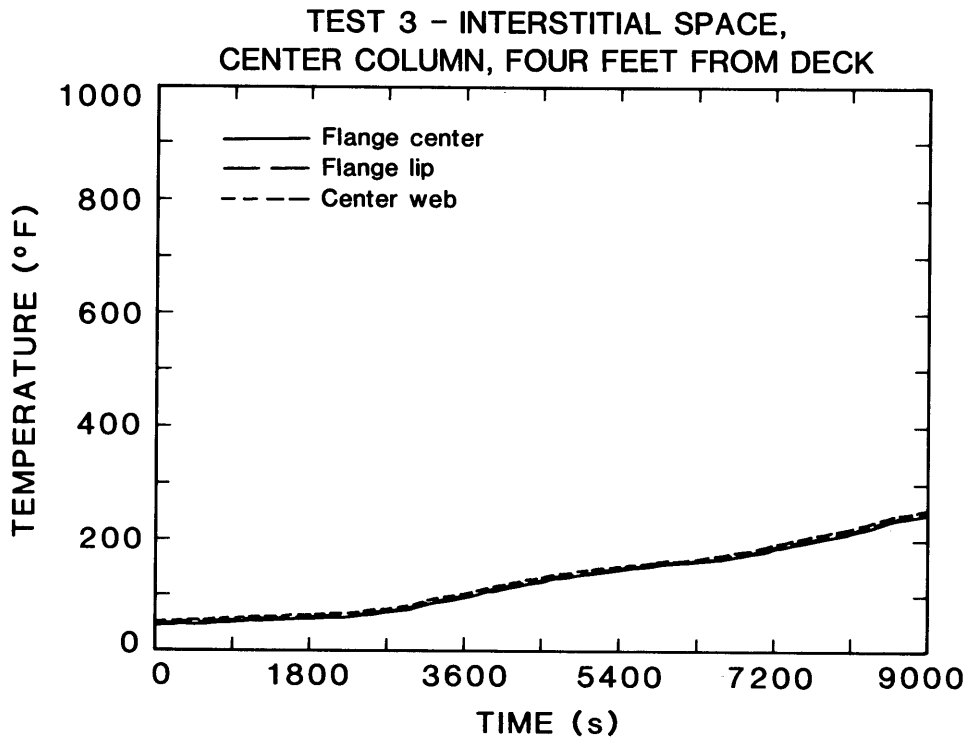
interstitial space also showed relatively low maximum temperatures, figures 122 and 123. In figure 123, the measurement made at the column flange lip was discarded because of a thermocouple failure. The flange and web temperatures show similar results with measurements well below the critical 1200°F value. The protected part of the center column also performed well in this test, figures 124 to 127. After the initial two hours, the maximum temperature was still more than 60°F below the failure point.

Figure 122. Center column temperatures in interstitial space at measurement point two feet above walk-on deck, test 3

Figure 123. Center column temperatures in interstitial space at measurement point four feet above walk-on deck, test 3

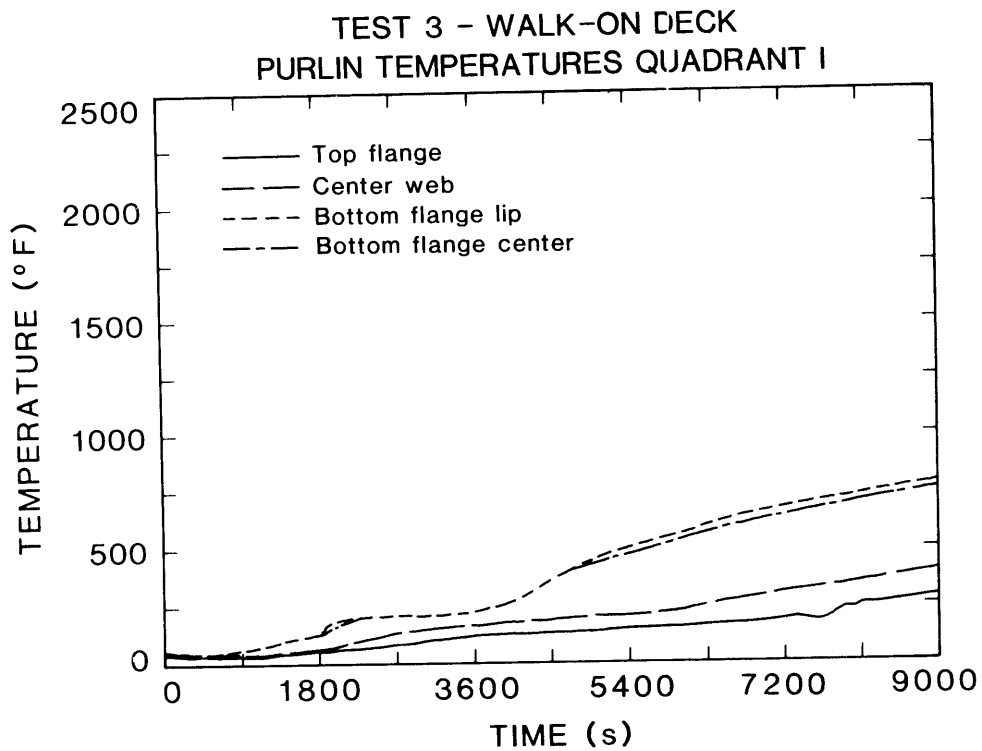
Figure 128. Walk-on deck purlin temperature quadrant I, test 3

Walk-on deck purlins did not achieve the same degree of success. This is shown in figures 128 to 131. The purlin which crosses quadrants III and IV experienced peak temperatures in excess of 1800°F on the bottom flanges. The earliest single point critical temperature limit was reached in quadrant III at about 36 minutes into the test. The two measurement locations on this purlin also show failures for average temperature. These failures occurred at 1 hour 11 minutes for the purlin location in quadrant III and 1 hour 53 minutes for the purlin location in quadrant IV. Test observations noted in section 8.1.2 show that these critical temperatures relate directly to the fireproofing dropping off the purlin. This purlin, which failed, did not have its bottom flange wrapped with wire mesh before the fireproofing was applied. The other purlins that did have wire mesh wrapping performed well, and it indicates that it is important for purlin protection when glass fiber formboard is used in a system of this design. The observation noted in section 8.1.2 stating that large gaps were observed between fireproofing and the gypsum deck, where the glass fiber board burned out, supports this conclusion. The subpurlins' temperatures are shown in figures 132 and 133. These construction elements also experienced significantly high temperatures. However, it should be remembered that the subpurlin flanges
